**Phase I and Limited Phase II  
Environmental Site Assessment  
Proposed State Veterans  
Retirement Home Site  
Jonathan M. Wainwright Memorial  
VA Medical Center  
Walla Walla, Washington**

**March 2014**

**MARCH 31, 2014  
TTL PROJECT NO. 11012.01**

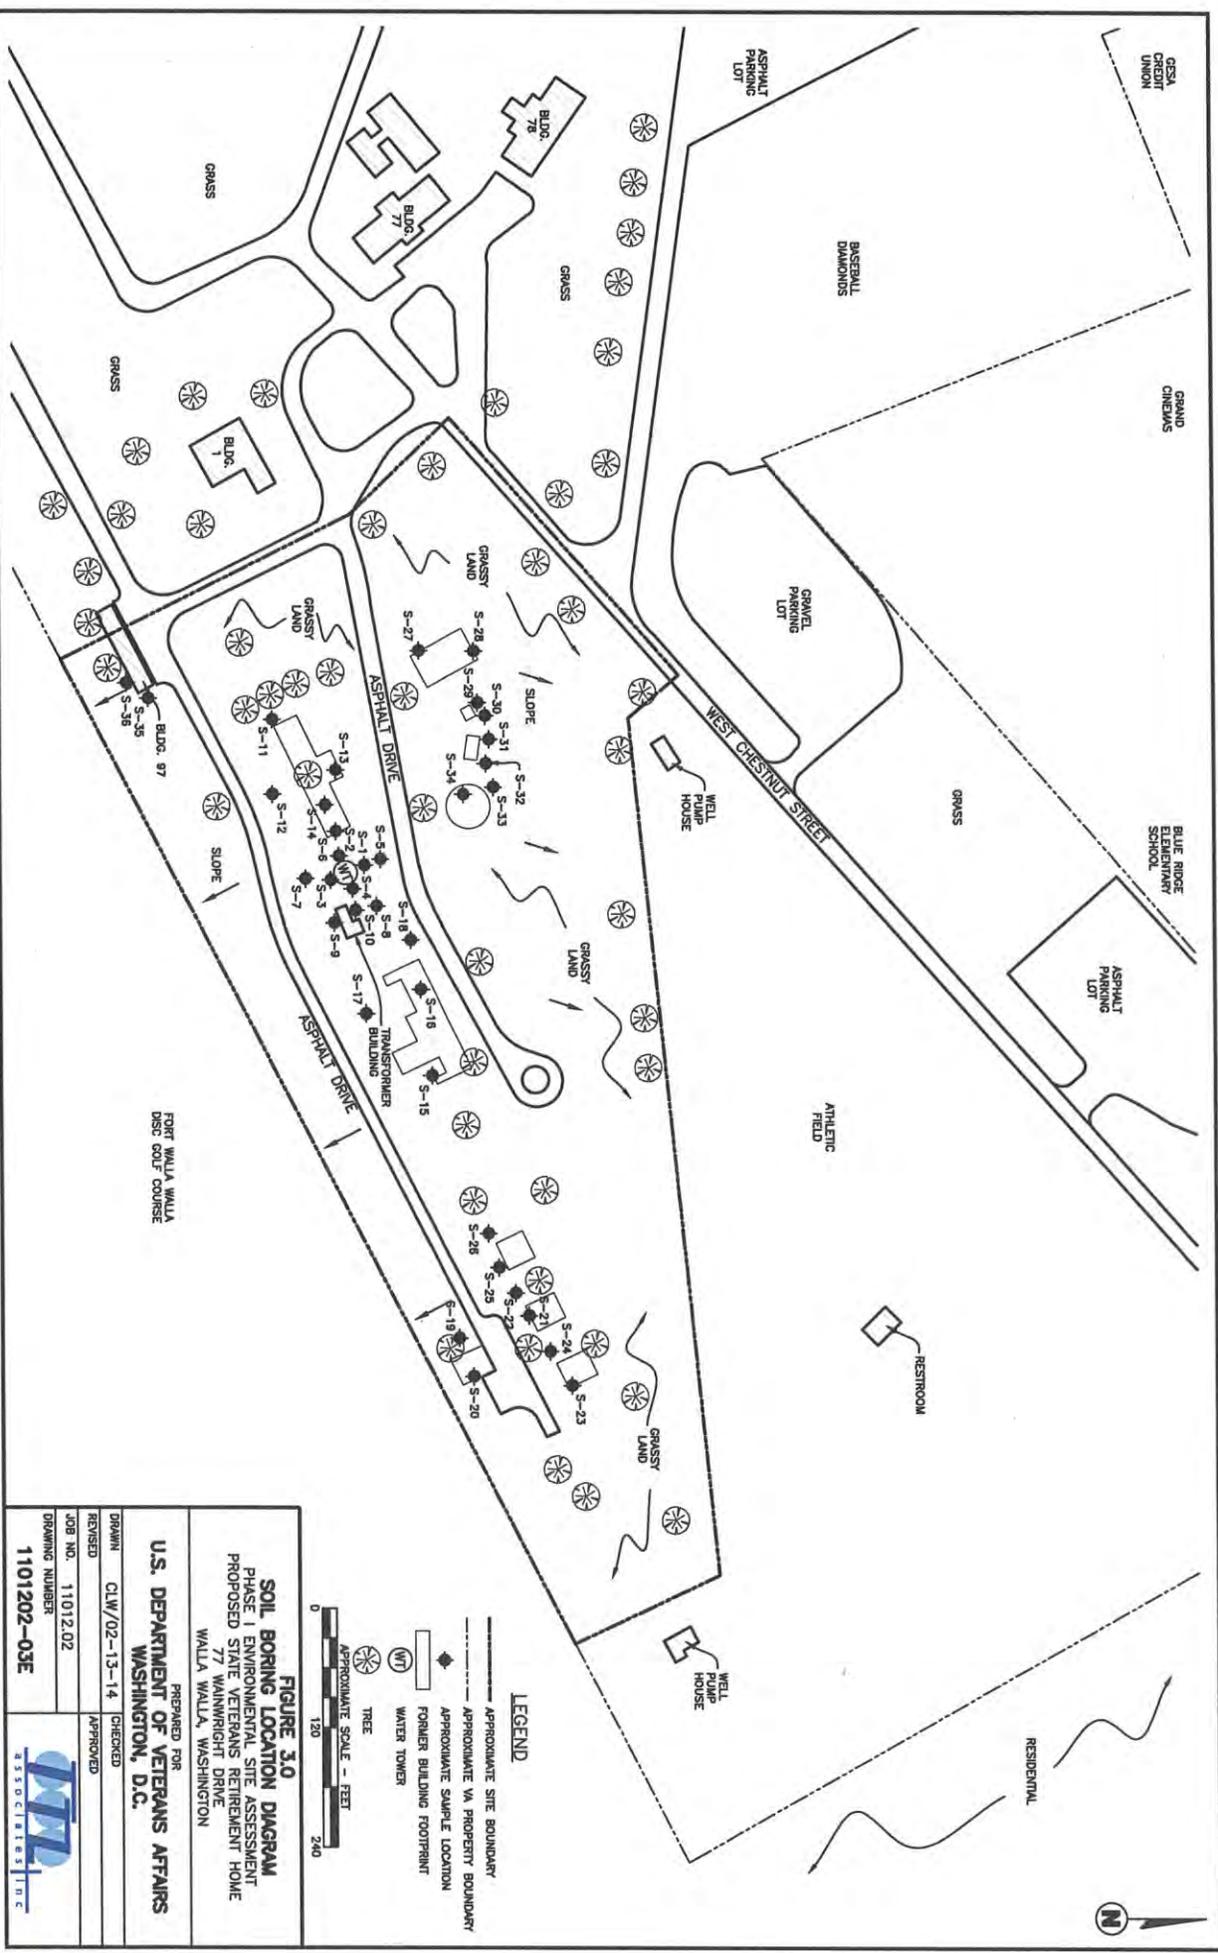
**FIGURE 3.0**  
**SOIL BORING LOCATION DIAGRAM**  
 PHASE I ENVIRONMENTAL SITE ASSESSMENT  
 PROPOSED STATE VETERANS RETIREMENT HOME  
 77 WANNWRIGHT DRIVE  
 WALLA WALLA, WASHINGTON

The soil samples were collected from approximately 2 to 6 inches bgs. A shovel was used to remove the grassy surface vegetation and shallow roots to expose the soil before sampling. The soils encountered generally consisted of sandy silt and clay. Paint chips were observed in soil samples collected near the water tower (S-1 through S-8) and near the east side of Building 97 (S-35). No discernable sand blasting material was observed in any of these samples. Demolition debris (plaster, brick, wood, and ceramic) was observed mixed with the soil in the location of soils samples S-29 through S-34 (all located in the northern portion of the site).

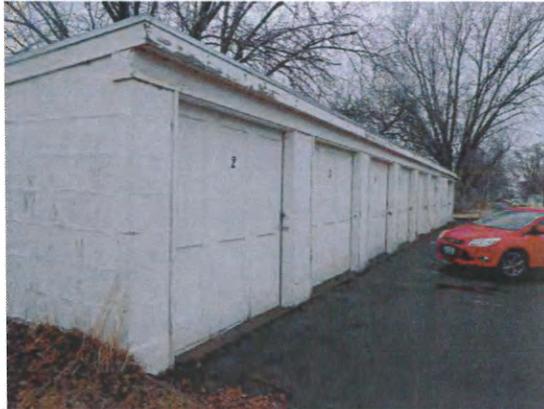
Paint chips were observed in the soil around the water tower and near the east side of Building 97. In addition, demolition debris was noted in the soil on the northern portion of the site. Seven of the 34 soil samples analyzed for lead contained lead concentrations in excess of the MTCA Method A soil cleanup level for unrestricted land use (250 ppm), including three samples collected at the base of the water tower (S-1, S-2 and S-4), one sample near former Building 46 (S-16), two samples near former Building 30 (S-31 and S-32), and one sample near Building 97 (S-35). Paint chips were observed in four of these samples (S-1, S-2, S-4 and S-35) and demolition debris was observed in two of these sampling locations (S-31 and S-32). No visible evidence of paint chips or fill was noted in the other sample (S-16).

Photo #7: Looking southwest at Building 97 in the southwestern portion of the site

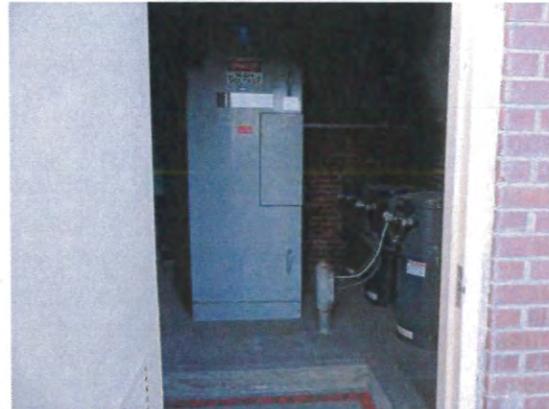
One pad-mounted transformer with three 37.5-gallon oil canisters was observed in the transformer building and did not appear to be leaking or damaged. The transformer equipment is owned by the VAMC. VAMC personnel stated that no release has known to occur from the transformer equipment. Some minor staining was observed on a concrete pad outside of the transformer building; however, the staining did not appear to be associated with the transformer equipment. The staining observed was de minimis in nature. In addition, soil testing around the transformer building during the Limited Phase II ESA did not identify any polychlorinated biphenyls (PCBs). Refer to Section 7.0 for additional details. Based on site observations and the soil sample analytical results, the transformer equipment is not considered to be a REC with respect to the site.

Photo #8: Transformer equipment

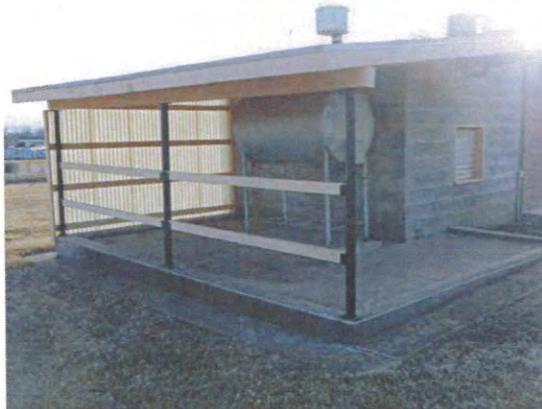
One 300-gallon diesel AST was observed adjacent to the east side of the transformer building and was associated with a small emergency generator located within the building. The AST was situated on a concrete pad with a roof and was in good condition with no evidence of a release. The AST appeared to be empty. Minor staining was observed on the concrete floor beneath the emergency generator; however, the staining was de minimis in nature. The AST and minor staining associated with the generator are not considered to be RECs with respect to the site.

Photo #9: Transformer building with AST

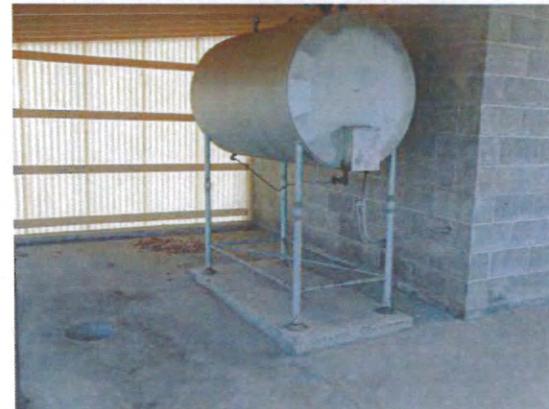
Photo #10: Close-up view of AST

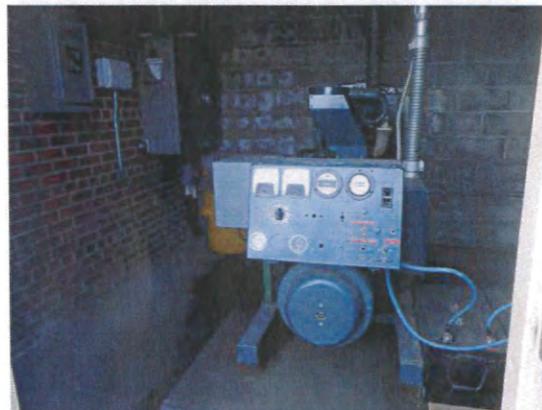
Photo #11: Emergency generator

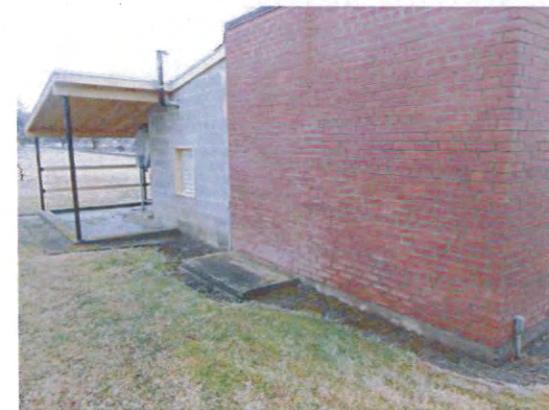
- Soil samples S-9 and S-10 were collected near the transformer building. S-9 was collected next to the transformer building door (whence transformer fluids would most likely have entered the soil in the event of a spill). S-10 was collected next to the slightly stained concrete slab outside of the building.

Photo #12: Transformer building with staining on the concrete slab in the foreground

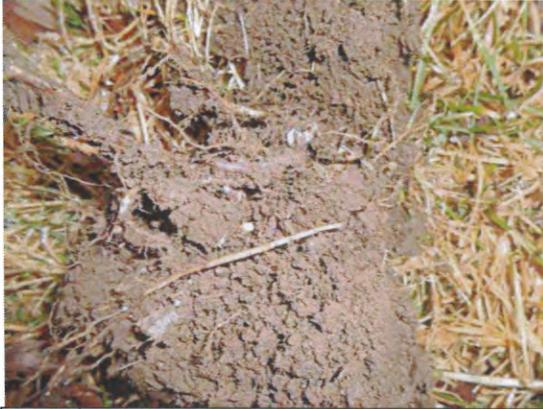
Photo #13: View paint chips in the soil around the water tower
